## 12.0 Mexican Hat, Utah, Disposal Site

### 12.1 Compliance Summary

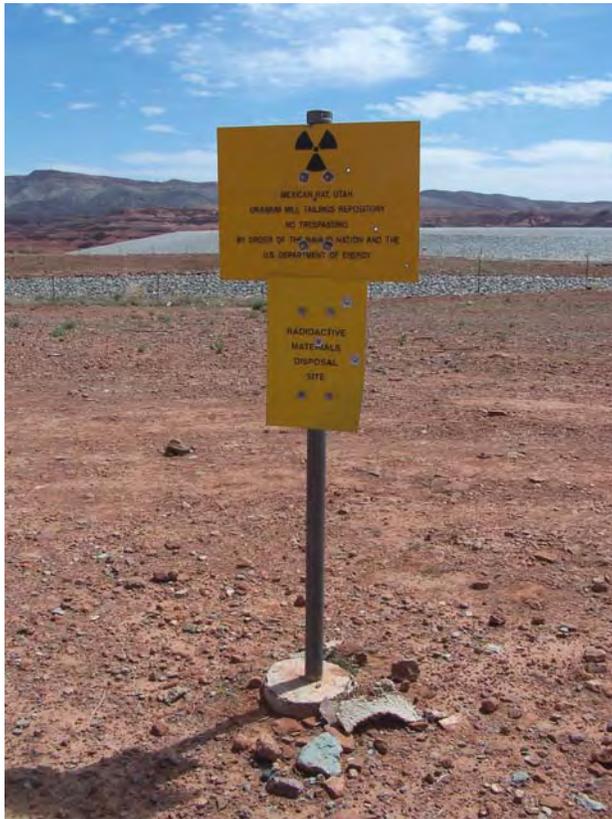
The entrance sign is located at the gate and was in excellent condition. There are 43 perimeter sign locations, and each location has a pair of signs: an upper property ownership sign and a lower radioactive materials disposal site warning sign. Perimeter sign P37, located along the west property boundary, was missing the lower radioactive materials disposal site warning sign. The remaining perimeter signs were present and legible, although several are bent or are damaged by bullet holes. Several signs, including P40, have new bullet holes (PL–1).

12B Trespassing just inside the disposal site property boundary (outside the perimeter fence) occurs in the same areas where trash accumulations are noted, as evidenced by vehicle and all terrain vehicle (ATV) tracks. Vandalism has increased, as indicated by new bullet holes in several perimeter signs. This is anticipated to be an ongoing problem at the site. In 2005, representatives with the Navajo UMTRA/Abandoned Mine Land office met with members of the local community to raise awareness and express concerns over these issues.

*HAT 4/2008. PL-1. Perimeter sign P40*

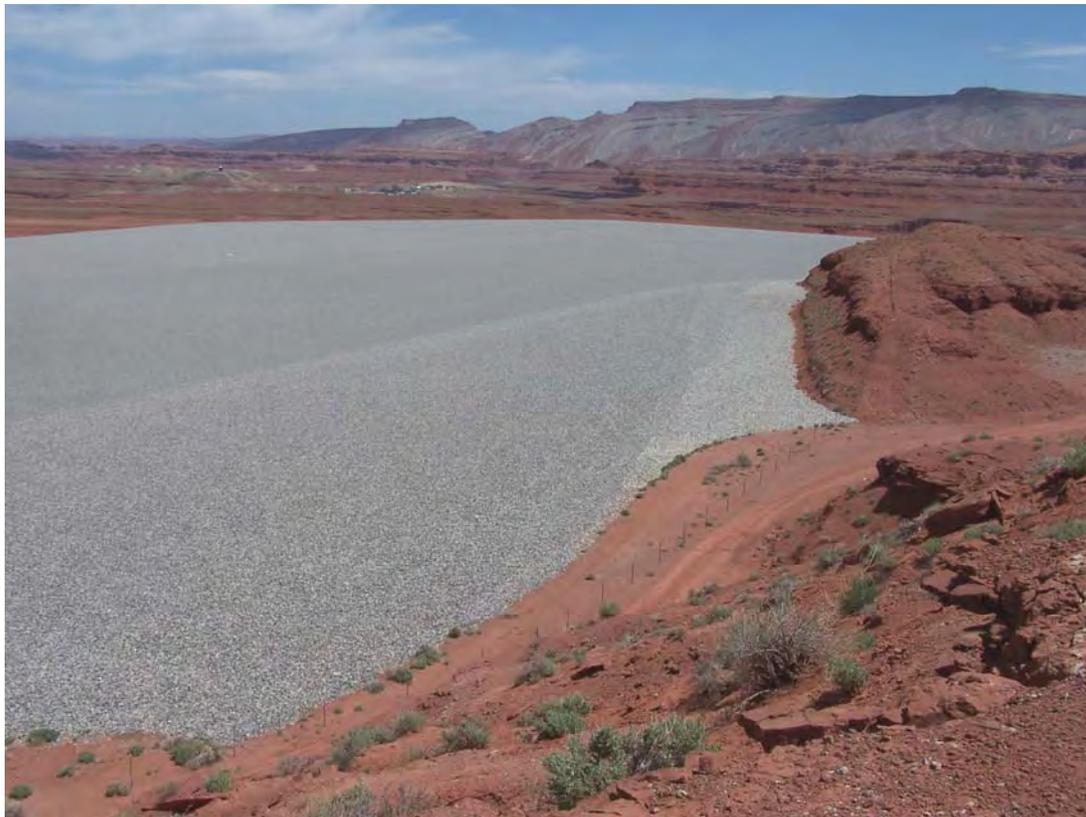
**Top of Disposal Cell**—The top of the riprap-armored disposal cell was in excellent condition (PL-2). There was no evidence of differential settling, cracking, burrowing, or other modifying processes that could affect the integrity of the cell. All visible components of the disposal cell and cover were functioning as designed. No vegetation was observed to be growing on top of the disposal cell.

*HAT4/2008. PL-2. The southeast portion of the disposal cell.*

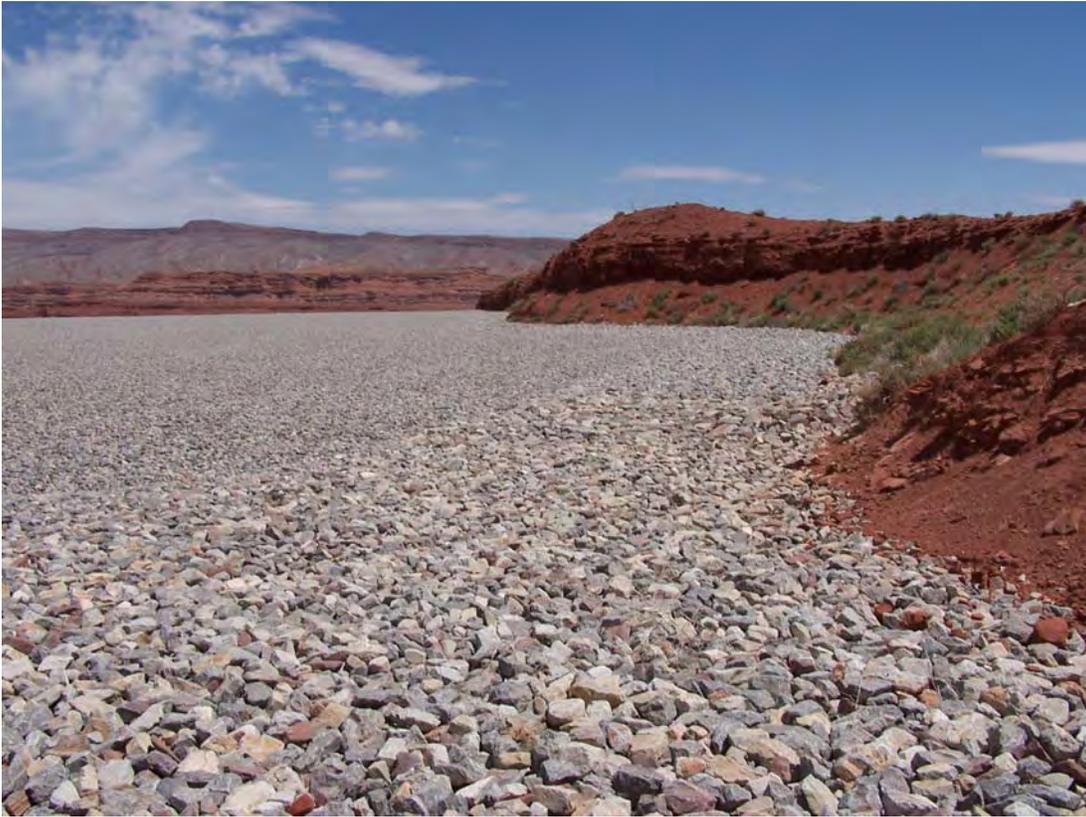
The sloughing of red country rock and soil along the south apron does not appear to have increased significantly during the past year. Because the apron in this area is immediately adjacent to the steep rocky cliff face along the southern edge of the disposal cell cover (PL-3), it is anticipated that a certain amount of sediment and unstable rock from the cliff face will, over time, continue to fall onto the apron. This area has been inspected for several years with little or no change being observed from year to year. The relatively minor accumulation of material that is anticipated to occur from year to year is expected to have no detrimental impact on the performance of the apron or the disposal cell. As a best management practice, inspectors will continue to monitor this area; however, no detrimental impact on the performance of the disposal cell from this fallen material is expected.

*HAT 4/2008. PL-3. The disposal cell apron along an area that tends to slough.*

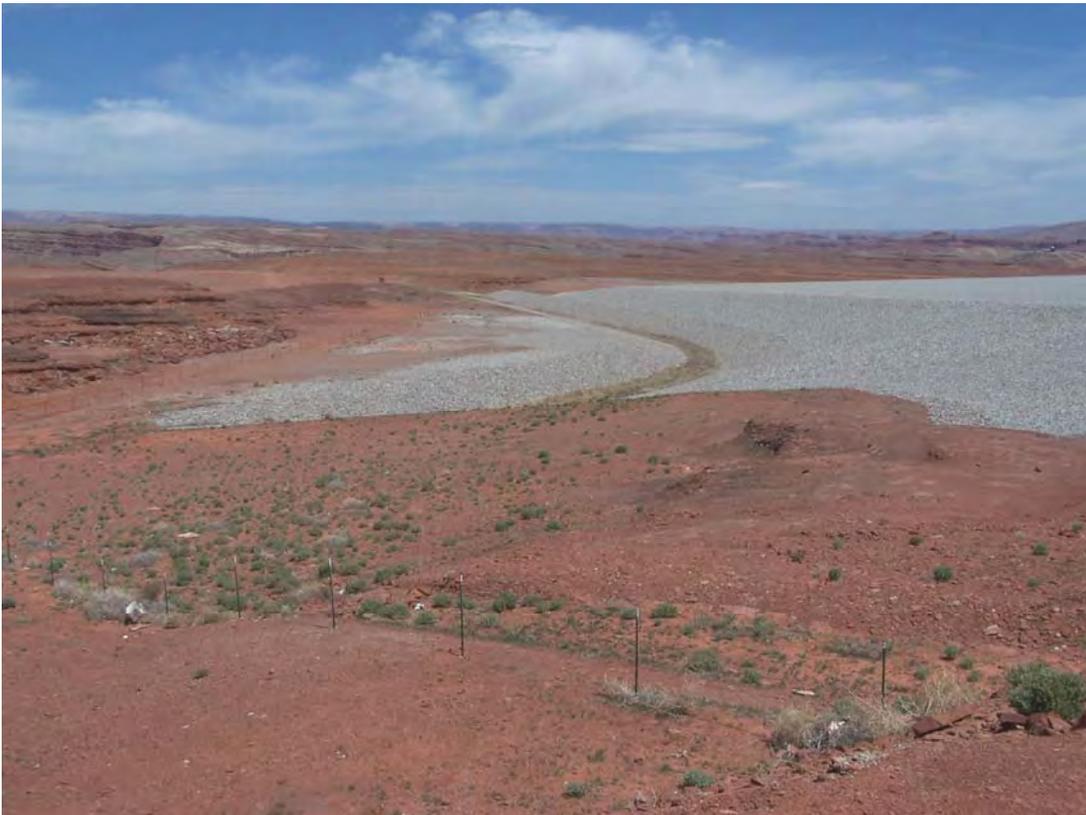
Areas off site and upgradient continue to erode and transport sediment onto the site and into the West Diversion Channel (PL-4). The sediment accumulation has promoted the growth of vegetation in the channel, including perennial grasses and annual weeds; however, the sediment and vegetation are not affecting the performance of this drainage structure.

*HAT 4/2008. PL-4. The west diversion channel.*

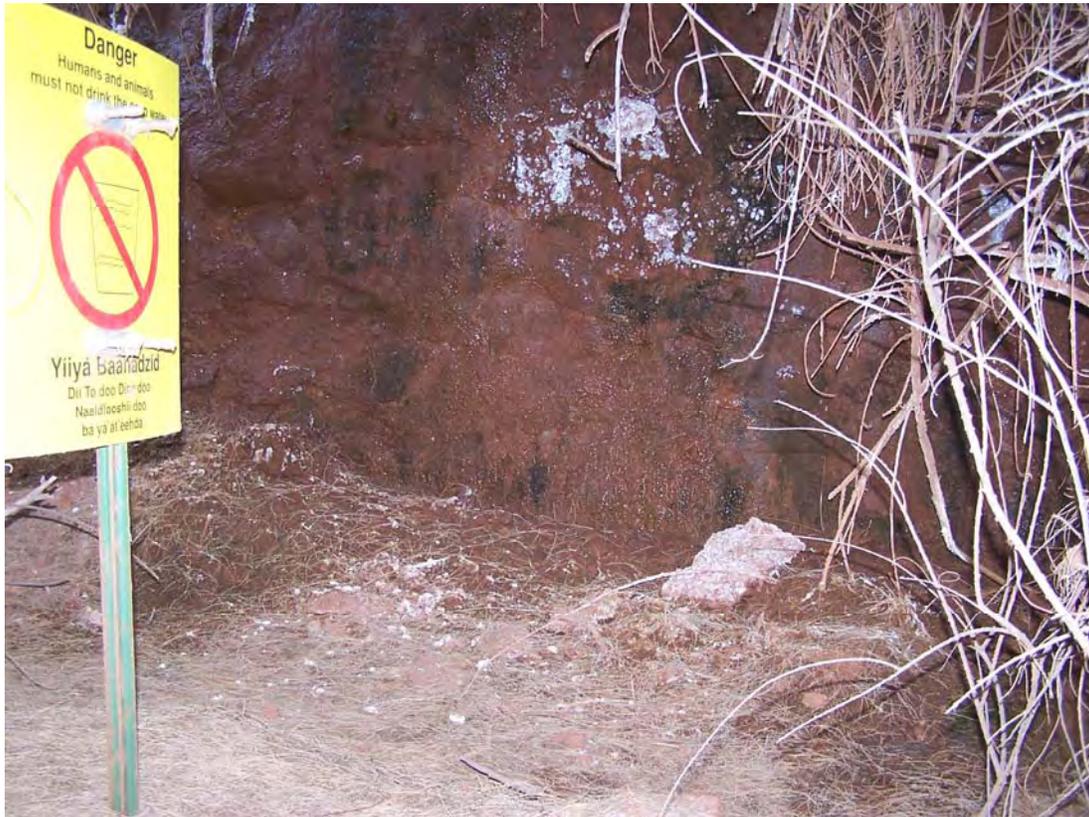
All seeps observed during the 2008 site inspection are listed in the LTSP, except Seep 0264 (which replaced Seep 0249 in 1995 because of insufficient flow for sampling). Minimal flow was observed only at Seep 0248 (PL-5). Only a minor amount of standing water was found in two of the Seeps—0248 and 0264 (PL-6); of the remaining four seeps, three were dry, and one had some moist soil. Table 12-2 provides observations and qualitative descriptions of seep flows.

The flow and small pool observed in Seep 0248, located in Gypsum Creek and cross-gradient from the disposal cell, were similar to observations during the 2 previous years. Seep 0264, located directly downgradient of the disposal cell at the confluence of North Arroyo and Gully 2, was wetter than observed in 2007 (only a small moist area was present at that time) but had less standing water than was observed in 2006. Seep 0251 had some moist soil (it was dry in 2007), and Seep 0922 was dry this year (minimal flow was observed in 2007). Seeps 0249 and 0254 continued to be dry.

*HAT 4/2008. PL-5. Seep 0248 in Gypsum Creek.*

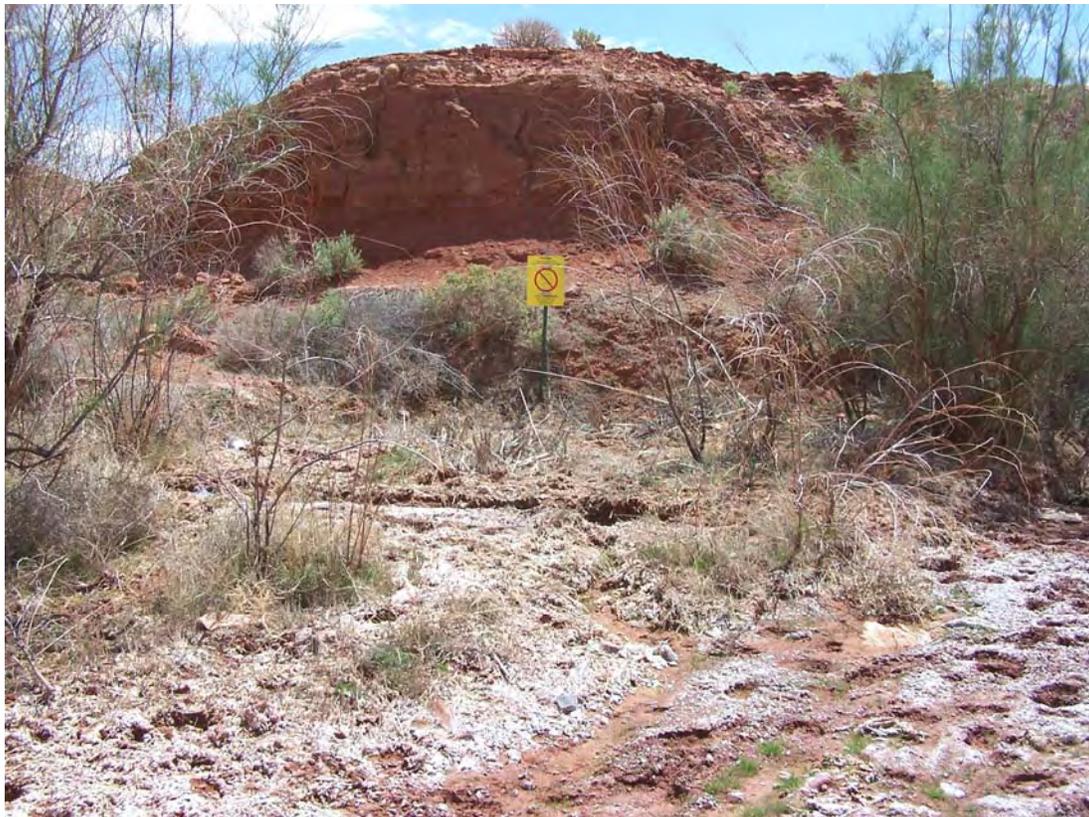
*HAT 4/2008. PL-6. Seep 0264 in the North Arroyo.*
